Tech Tips

Spyke Rotors Rotor Pin Placement

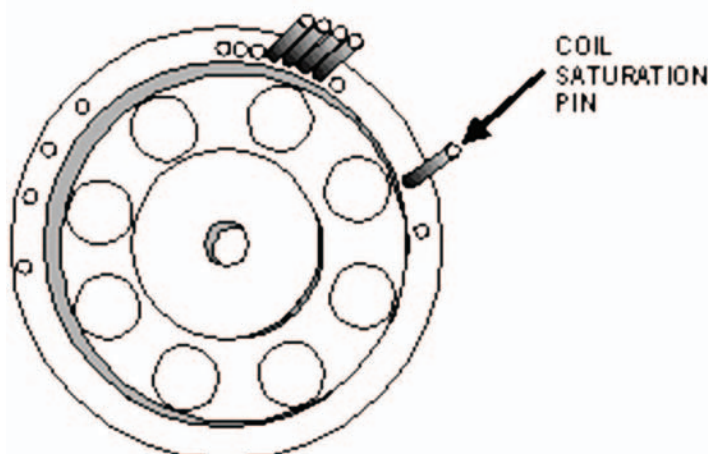
Distributor Mounted Ignition

Distributor Mounted Ignitions must be used with distributors that accept cam cover mount Ignitions such as SPYKE Quick Install Distributors.
